Observations of Frodingham 5 Sheet Piles at Bainbridge Island

10/04/16

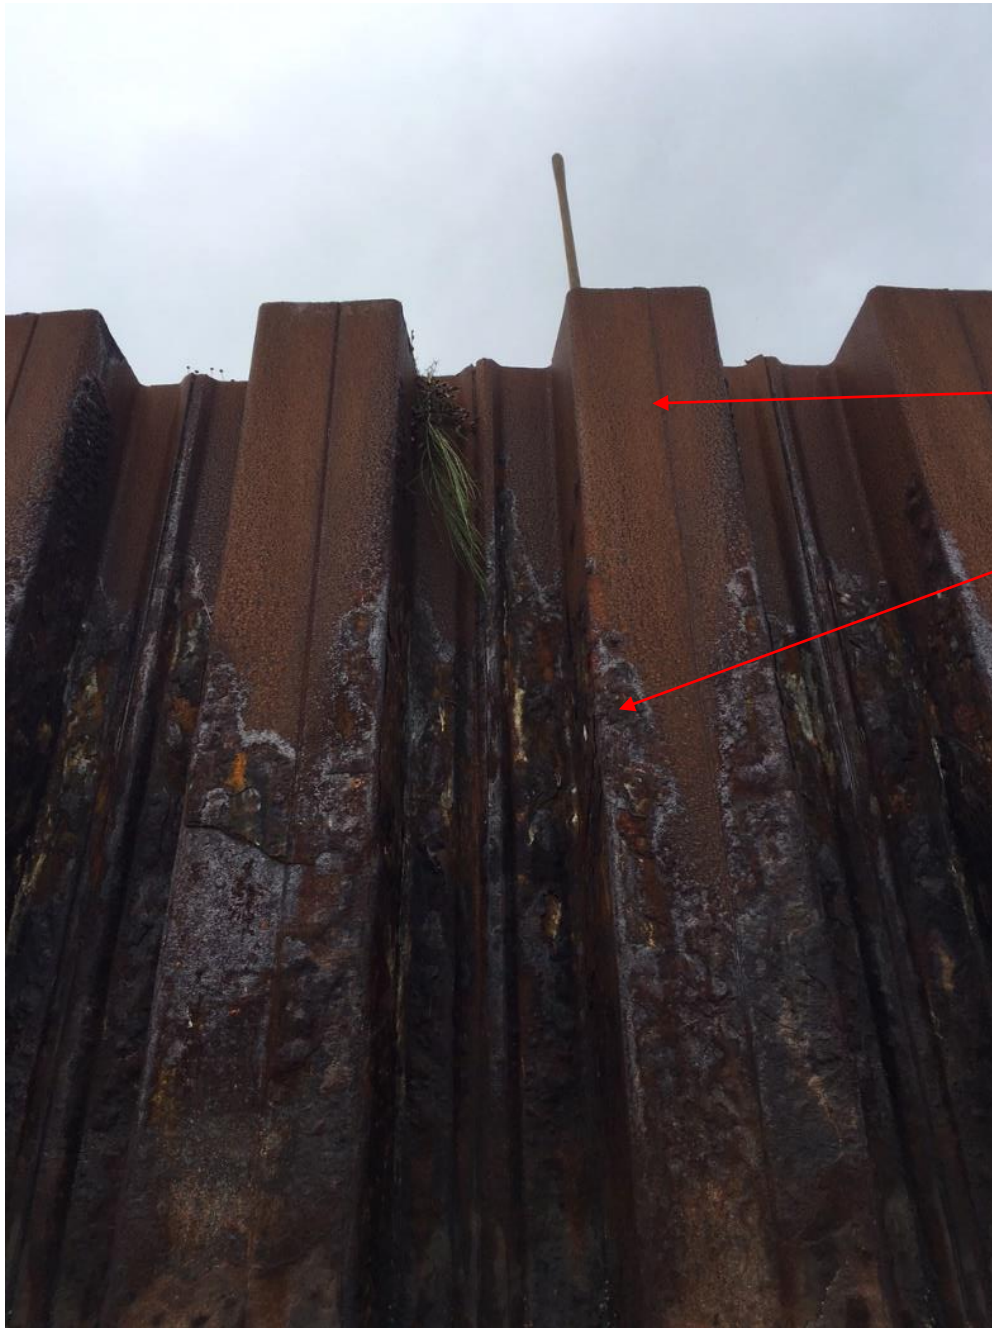
Slide 3 shows the corrosion products at the Splash zone with general oxidation above that in the Atmospheric zone.

Typical corrosion pattern throughout.
Atmospheric corrosion
followed by aggressive
Splash zone corrosion products.

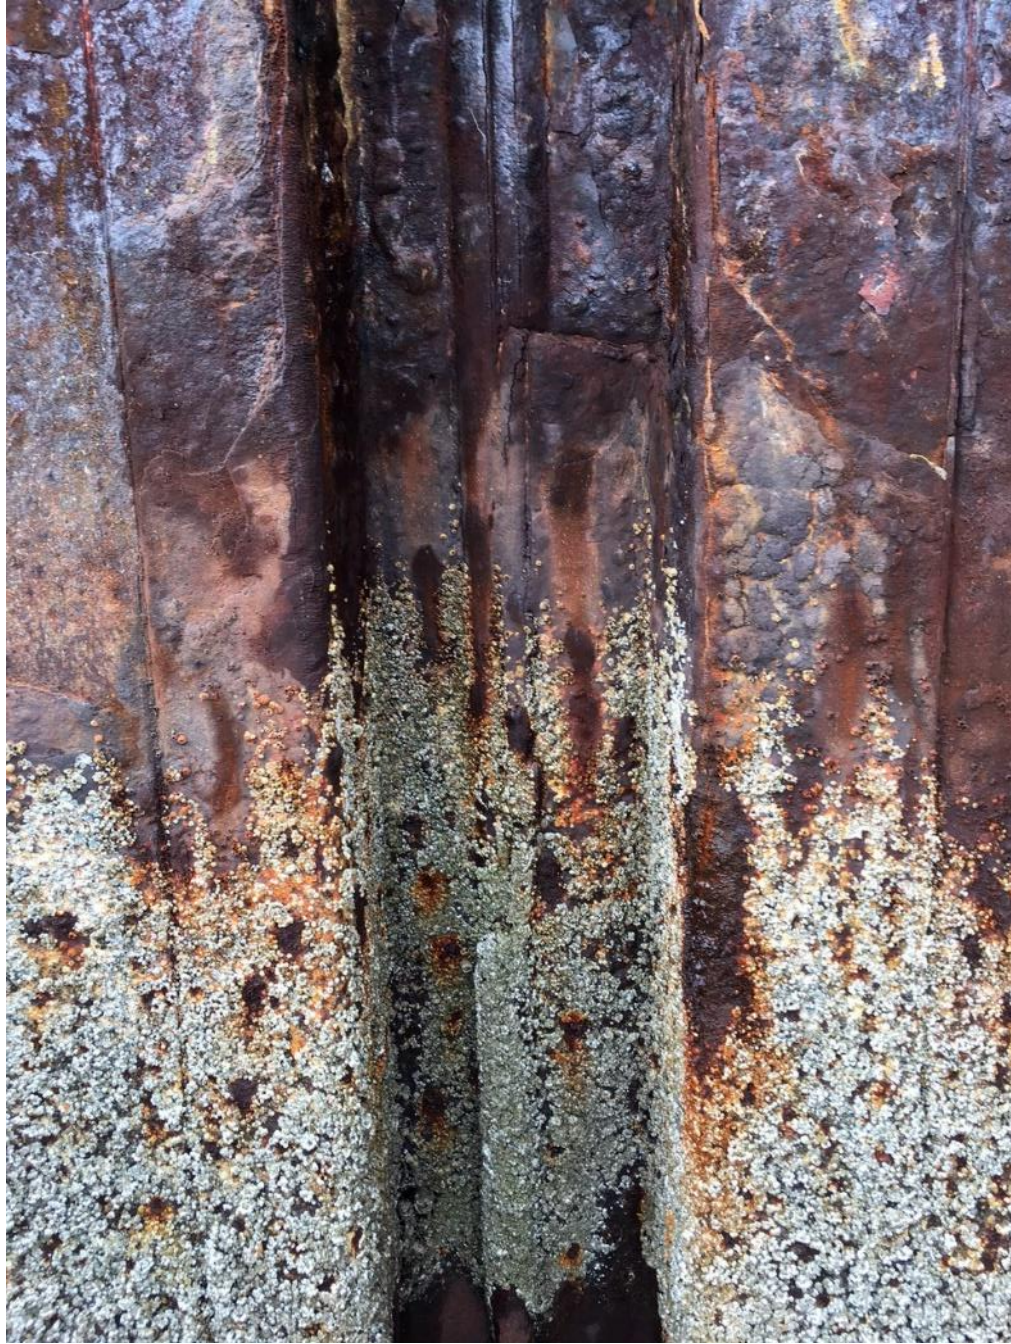
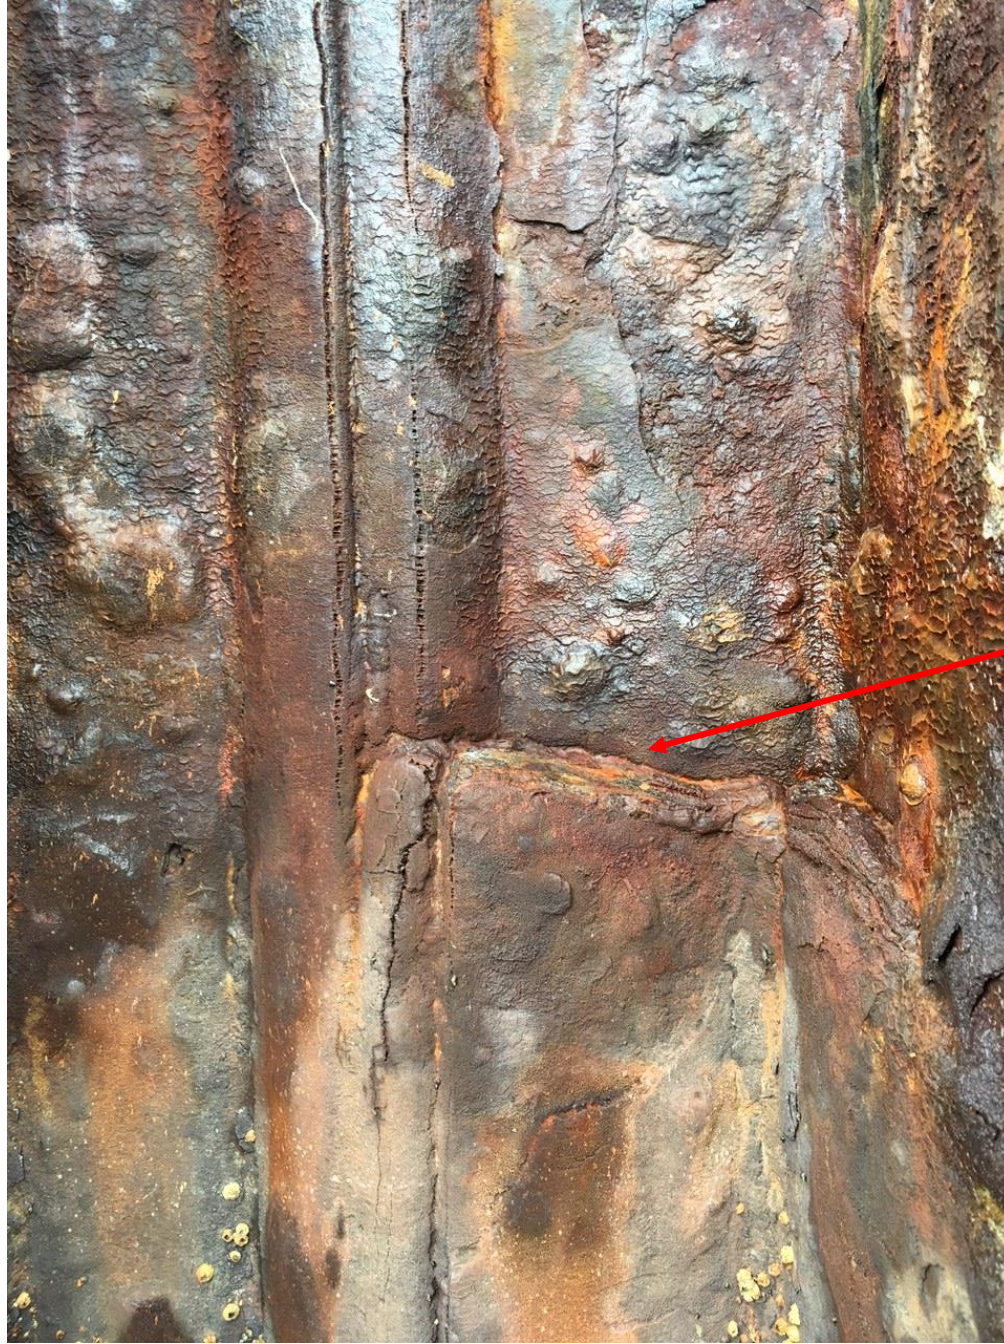
Slide 4 shows what appears to be a fabrication by the contractor possibly due to a damaged pile during driving.

Appears to be a
contractor splice

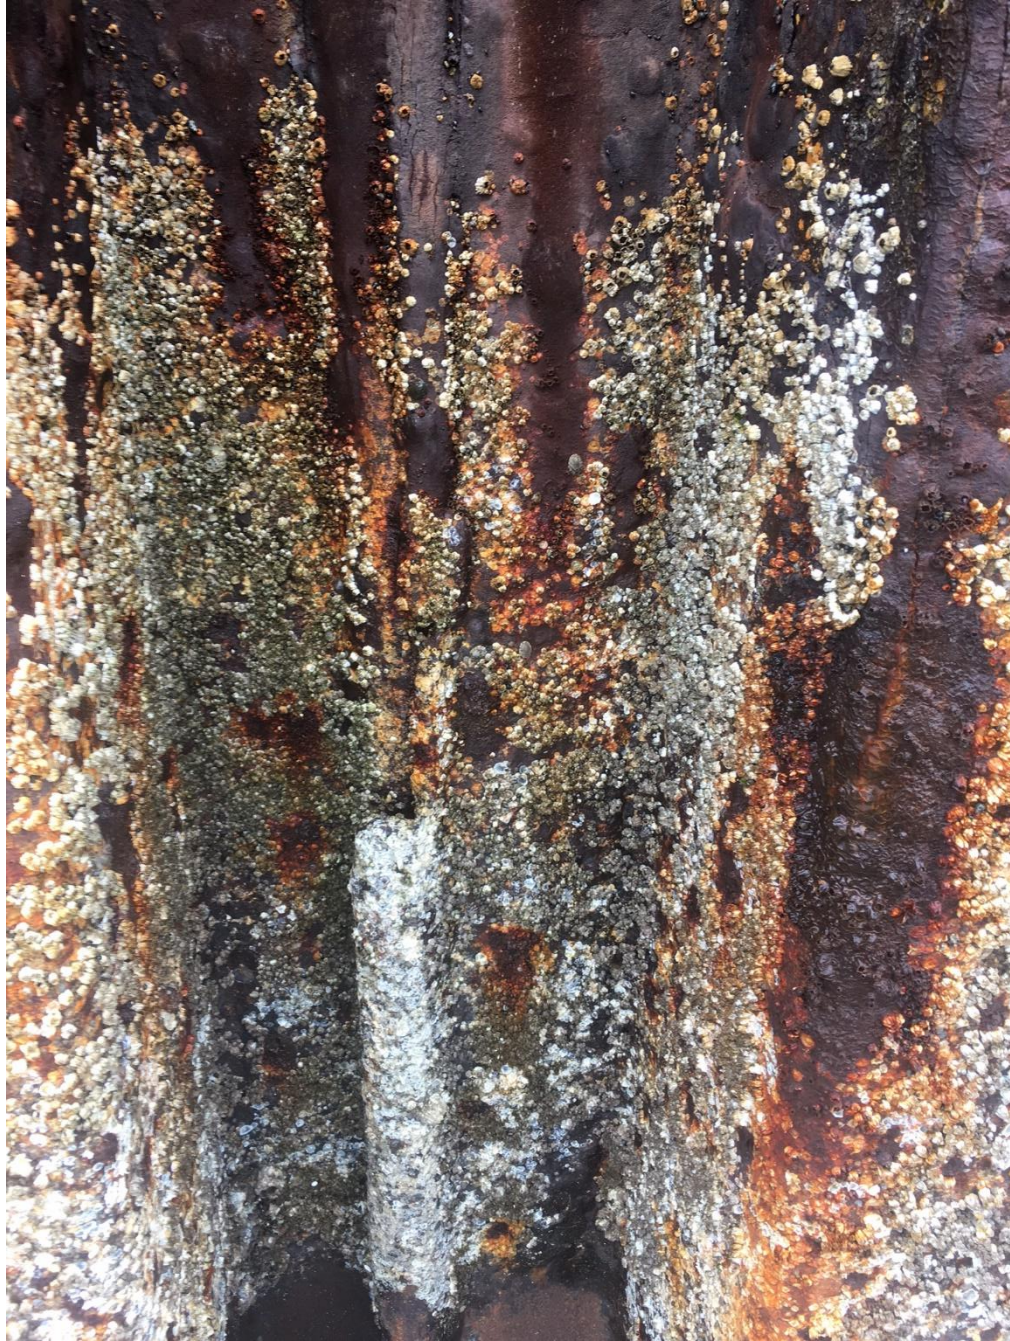
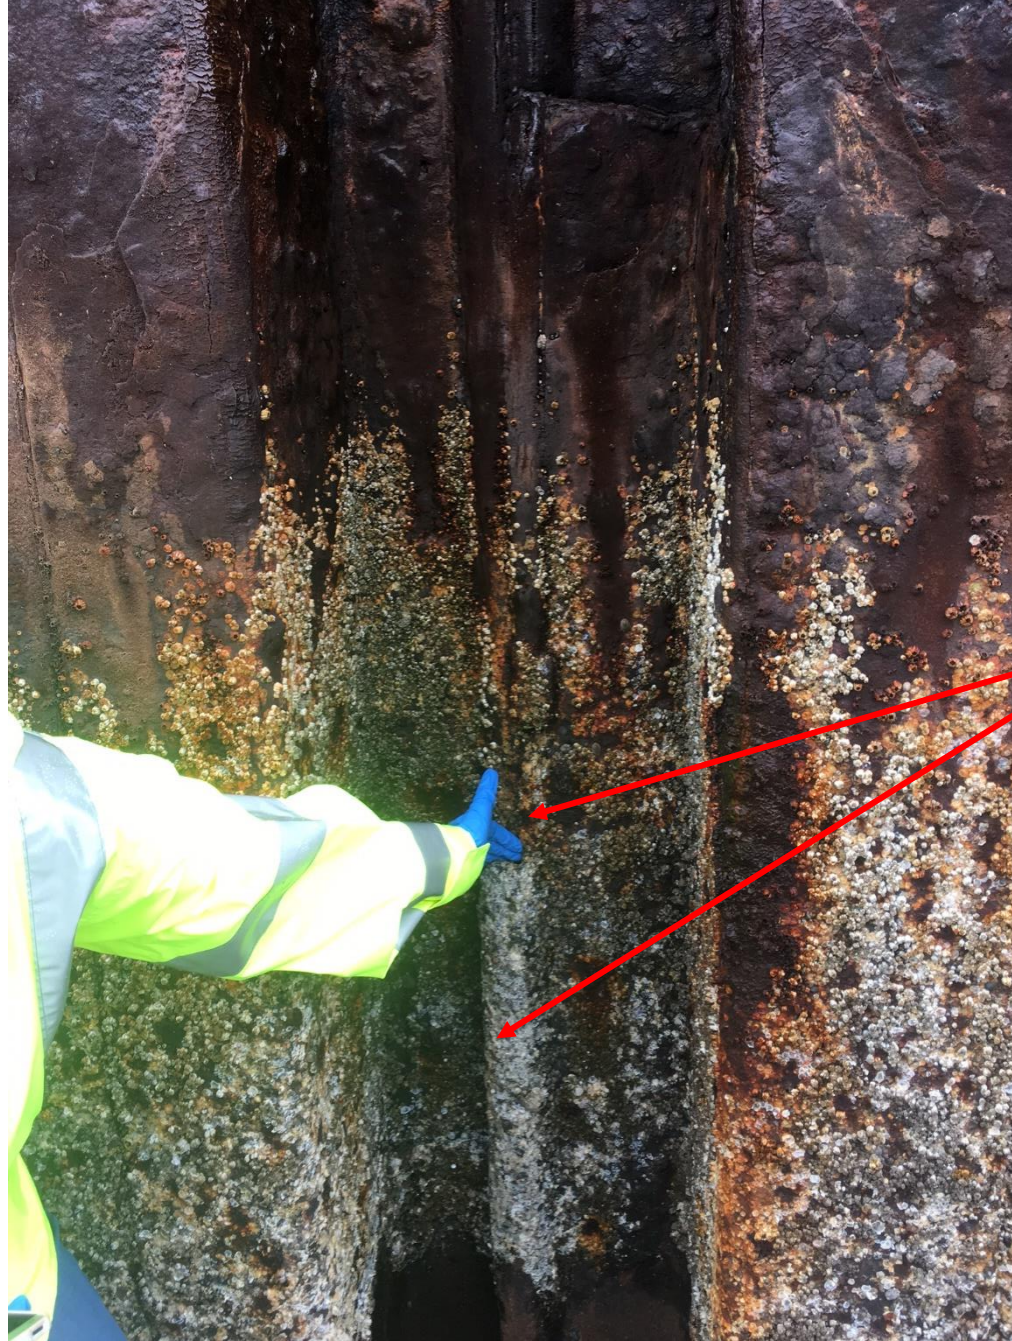
Slide 6 & 7 shows one of a number of piles that were completely or partially de-clutched. The completely de-clutched pile in pile 7 was likely never clutched at all. The partially de-clutched piles were most likely de-clutched during hard driving.

The wall alignment overall is not good and indicates difficult driving conditions forcing the wall line out of positional placement in a number of locations. This would account for the isolated de-clutching noted above.

Pile de-clutching

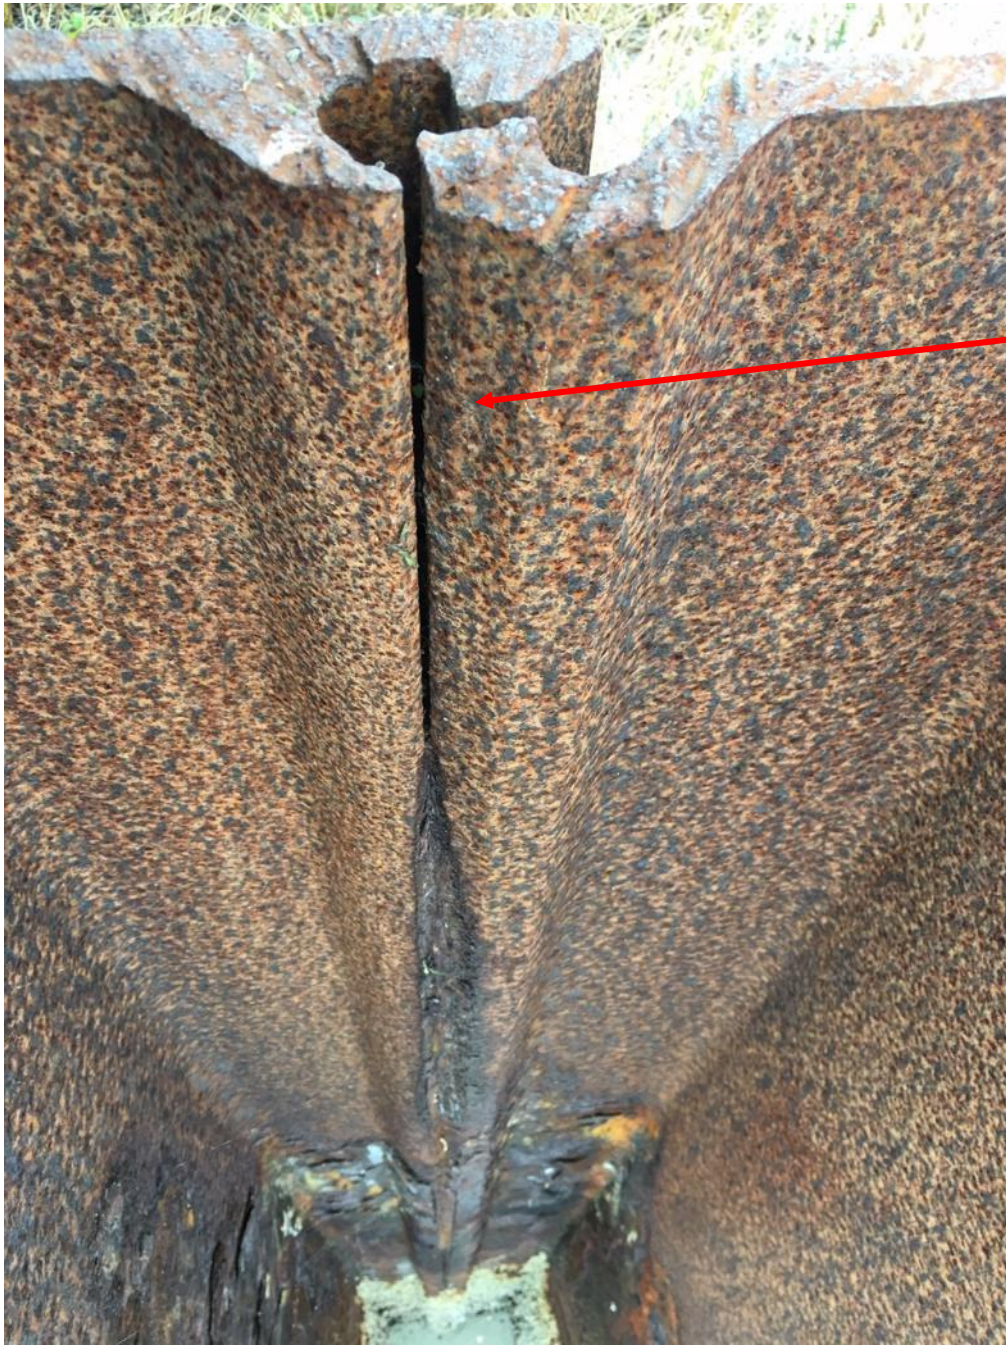
Pile was never
interlocked

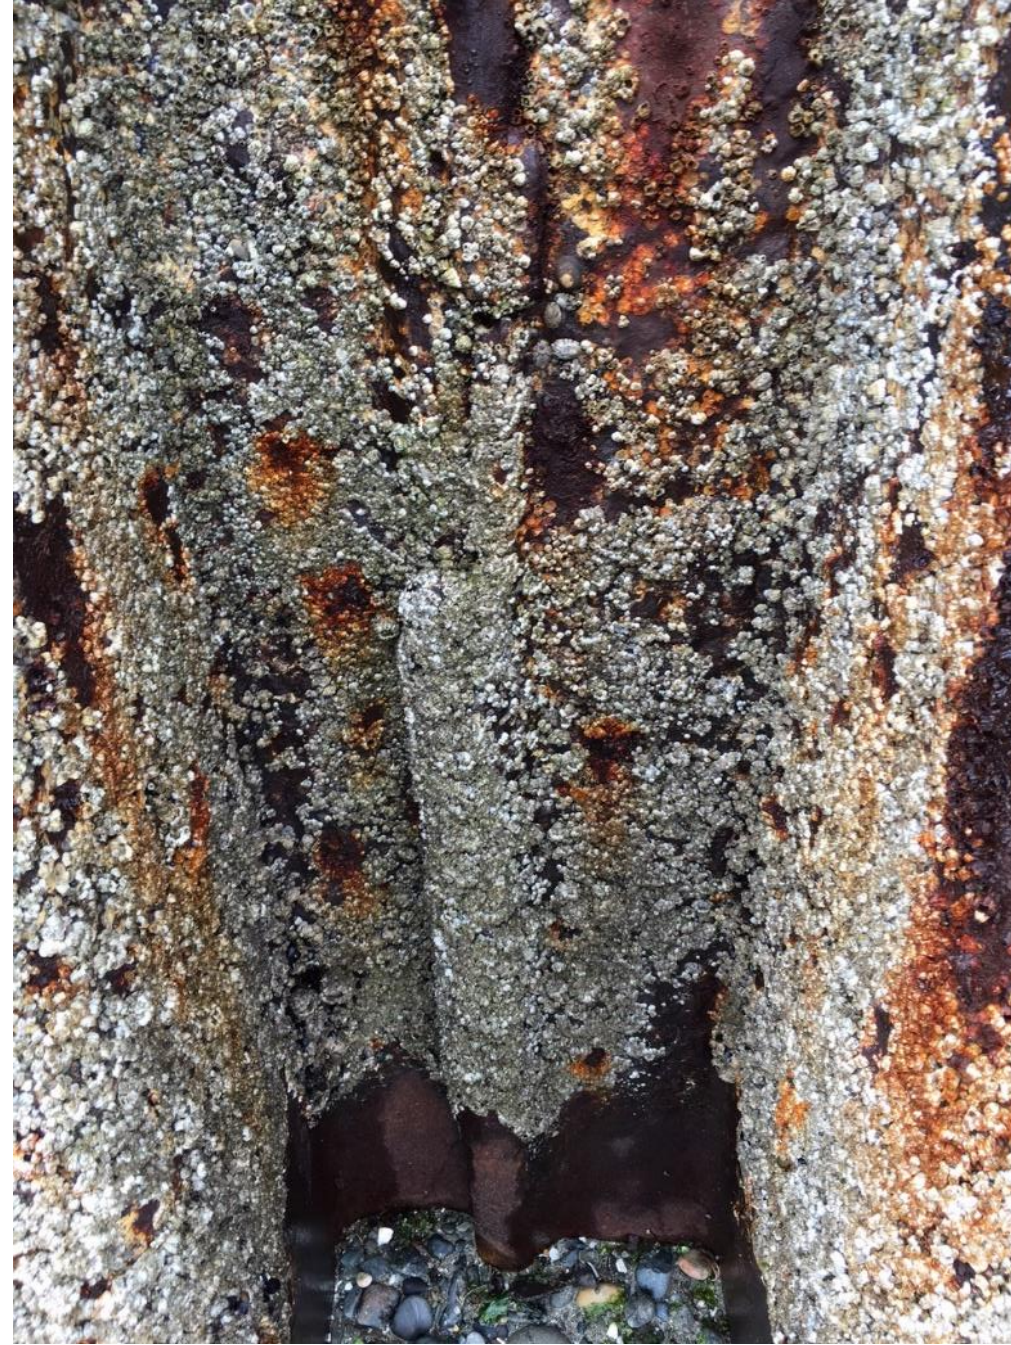
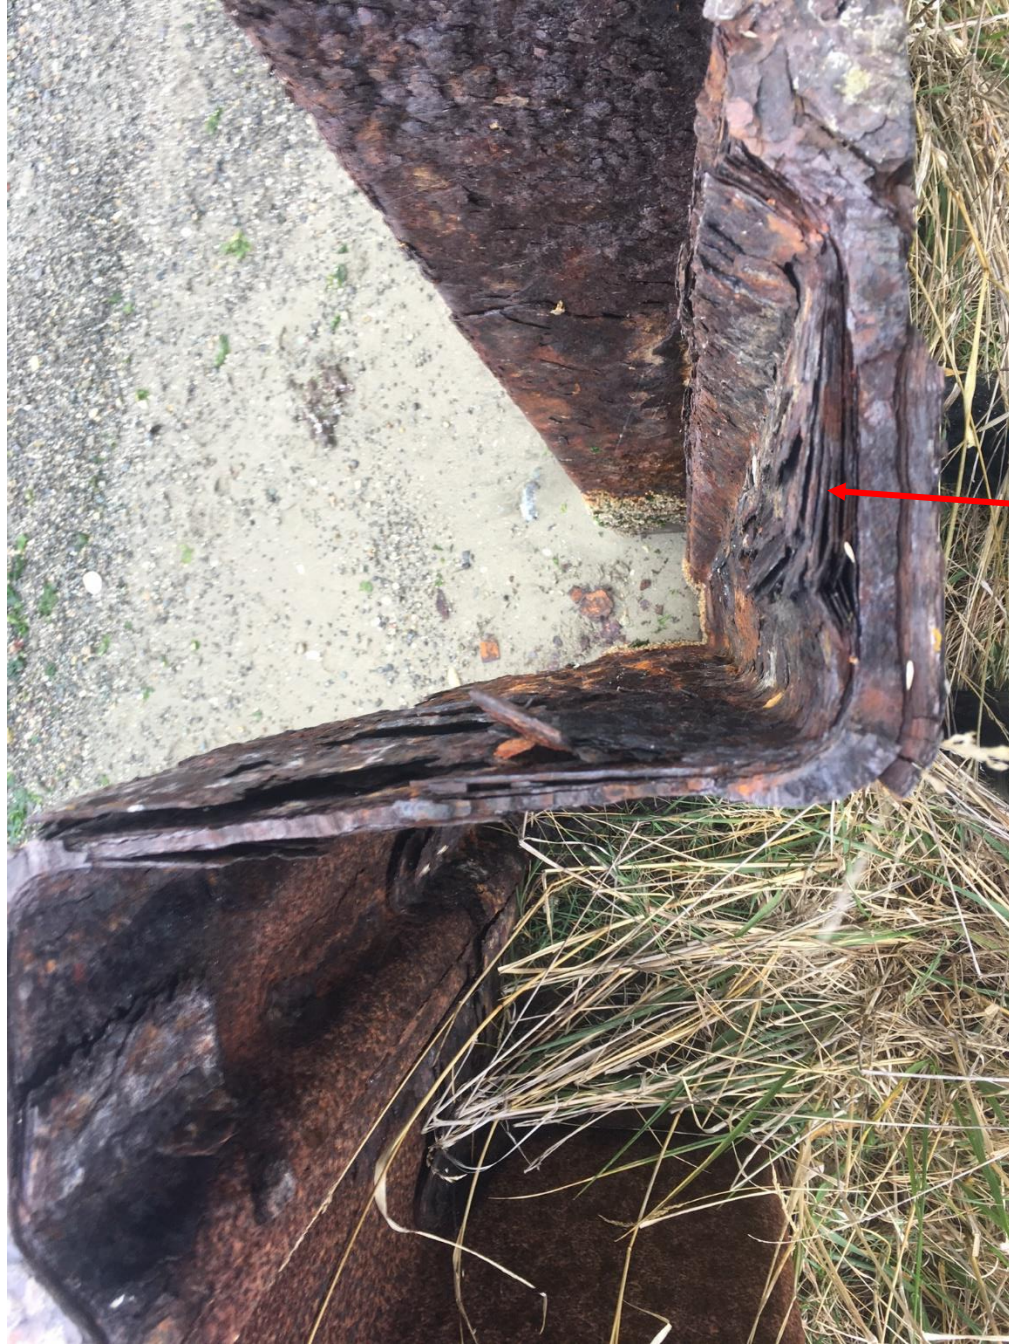
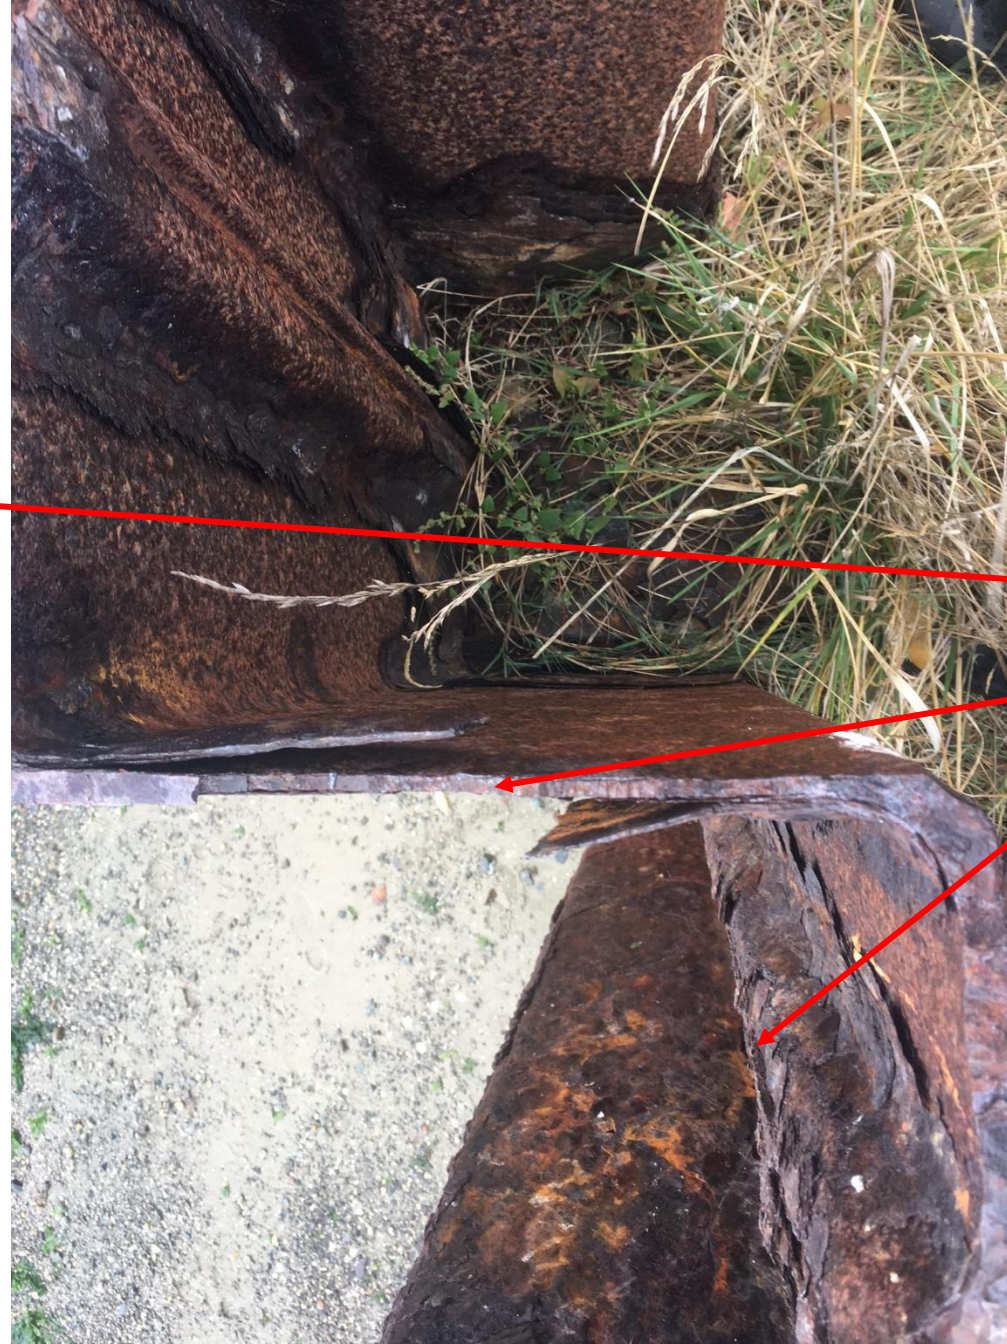
Slides 8 & 9 clearly show the excessive loss of thickness from the steel laminating even at the top of the piles in what should be a more protected zone. The remaining steel thickness here is a cause for concern. The corrosion around the lock itself is so severe that the lock no longer has any connection structurally and could easily de-clutch under load.

The vertical cracking along the lock is not a normal form of breakdown of steel on a sheet pile. It suggests a higher level of stress across the lock surface and may have been propagated from micro cracks in the steel.

Severe corrosion
Lamination
Thinning of web
to approx. 5 mm
Vertical lamination
along exposed lock

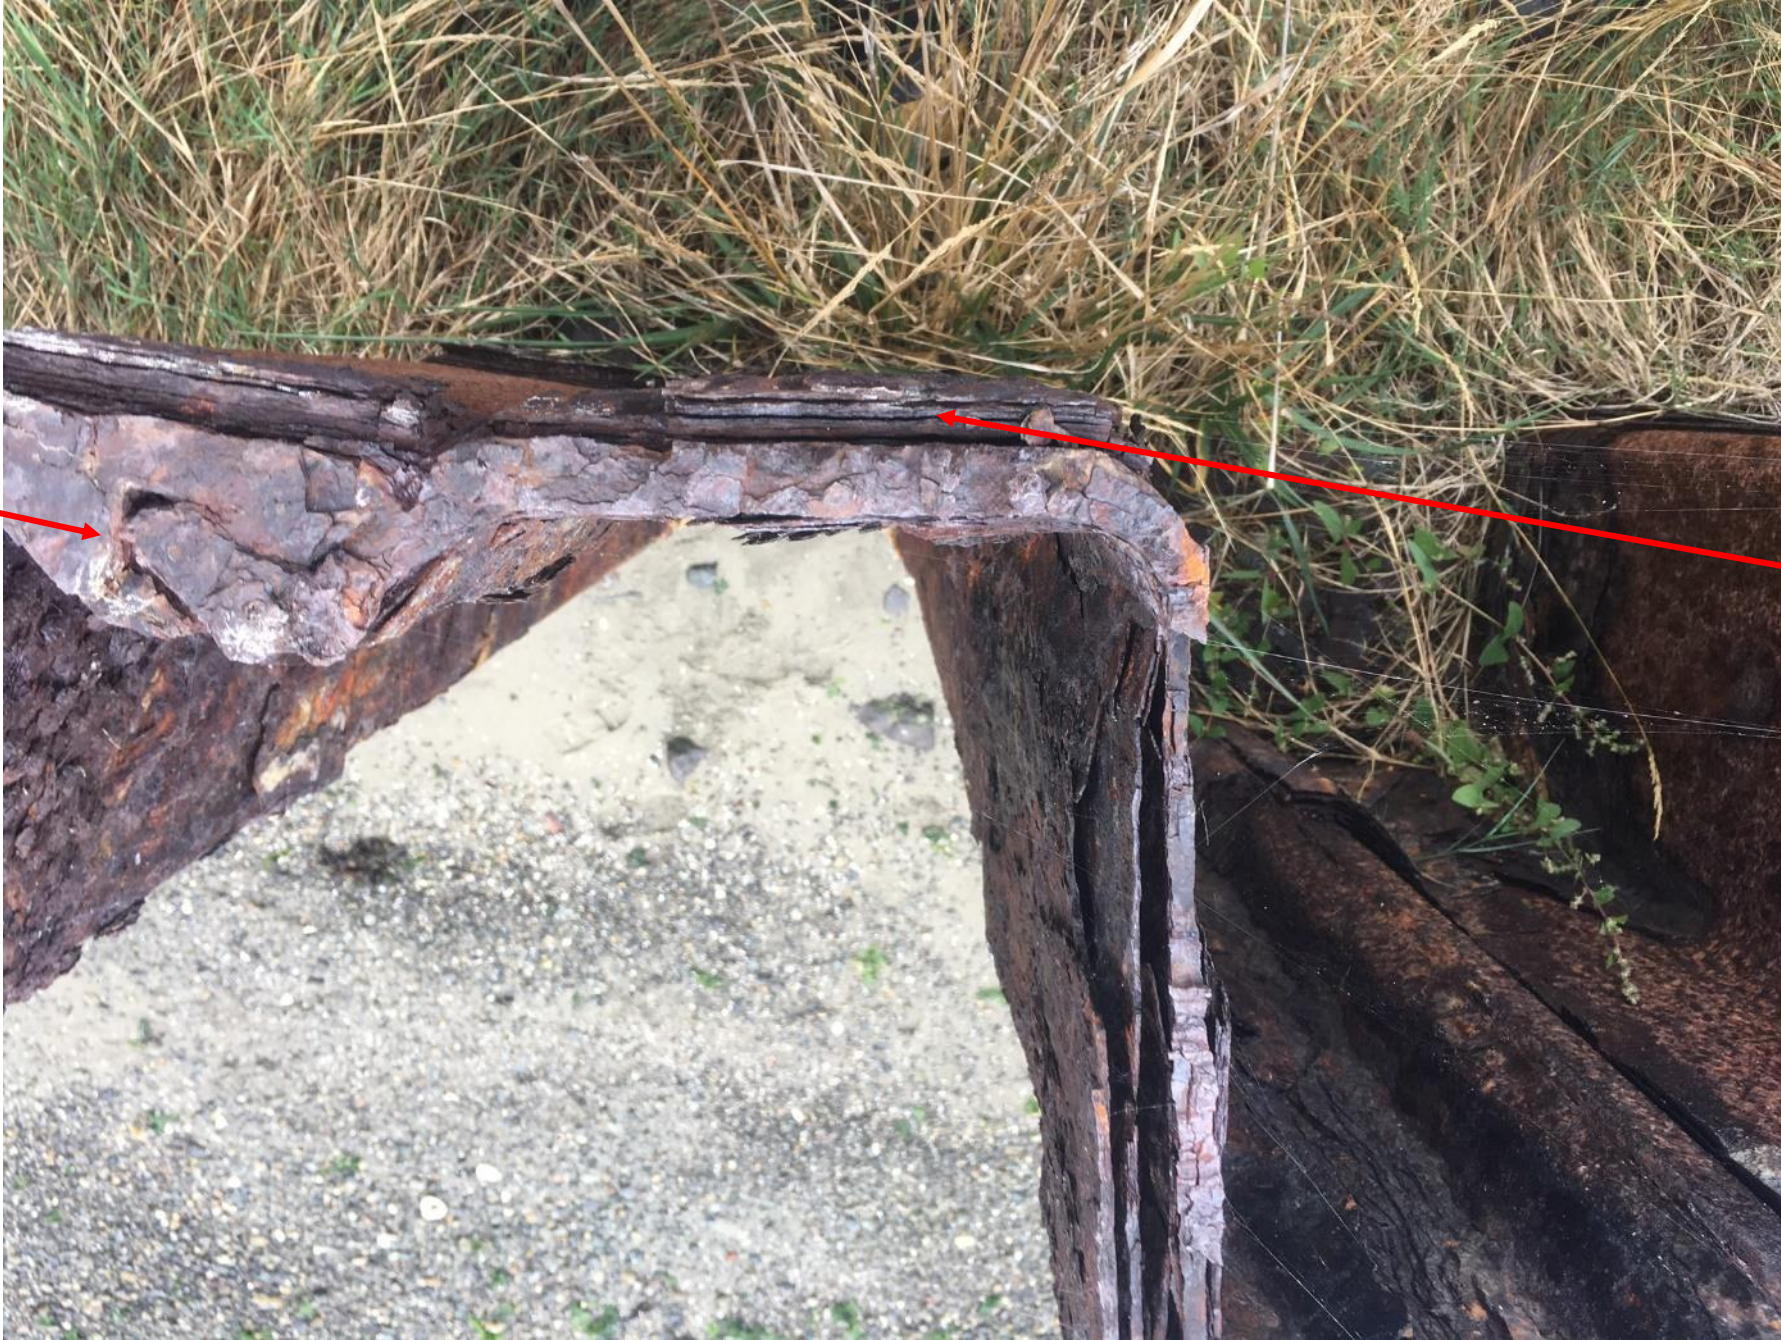
Slides 10,11 & 12 indicate excessive abrasion of the lock knuckle on the exterior in-pan on a number of piles. This has caused the finger to be completely worn away at the bed level. Based on visual inspection and reference to a CAD of the F5 around 21 mm of lock has been removed. This has occurred along a number of piles at the front (North?) face of the wall.

One cause may be abrasion from highly aggressive eddy currents at bed level churning up the sand bed. However it's unusual to have such abrasion without any visible scour.

Severe erosion
of lock knuckle
on exterior face
and loss of finger
thickness

Severe interior face
corrosion products

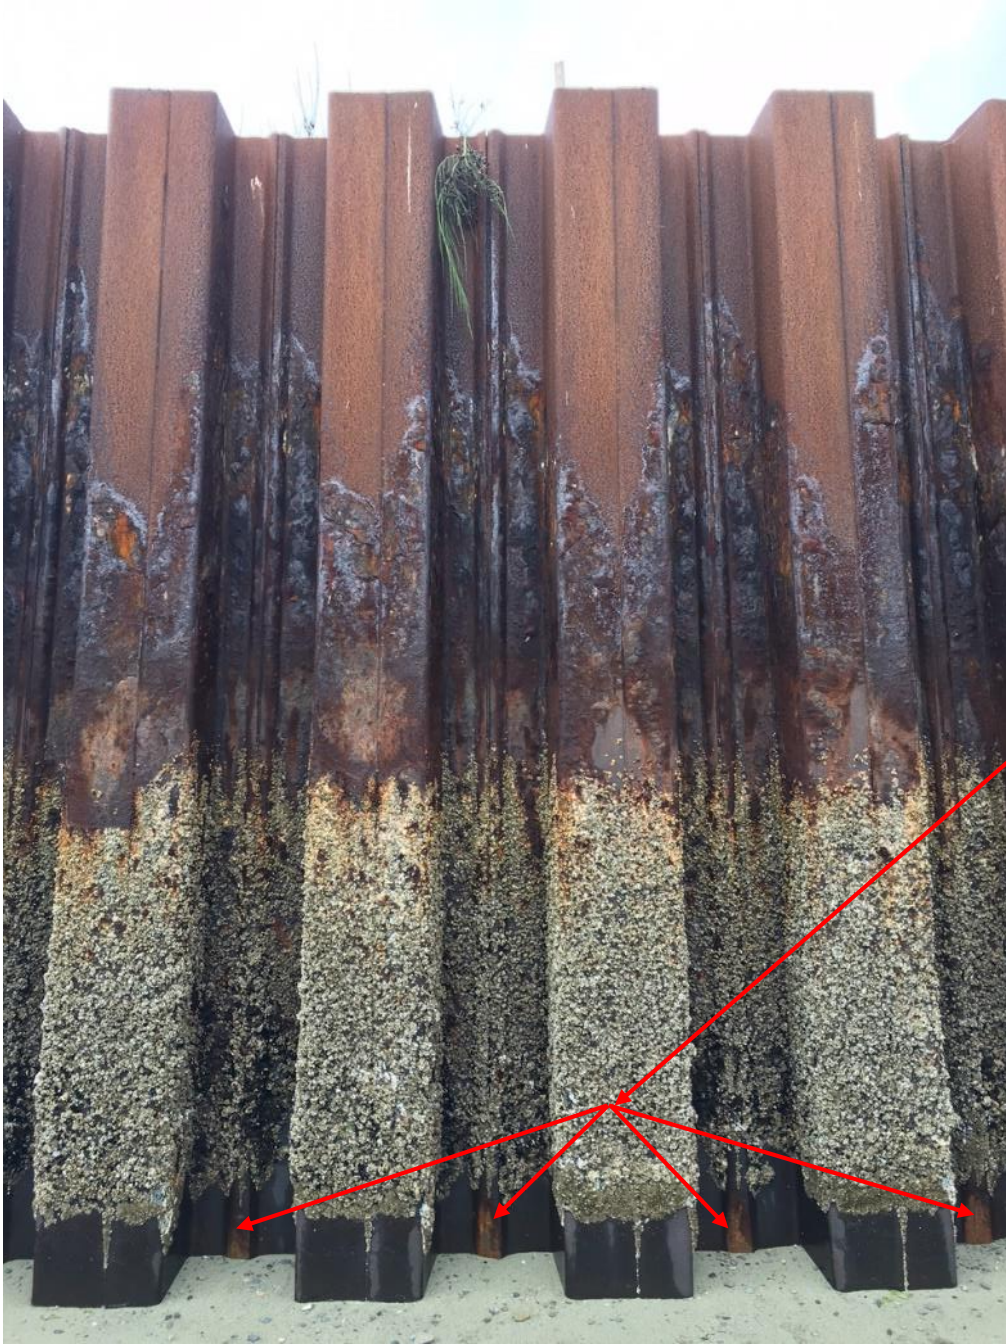
Severe loss of exterior lock thickness at bed level extending approx. 6" upward

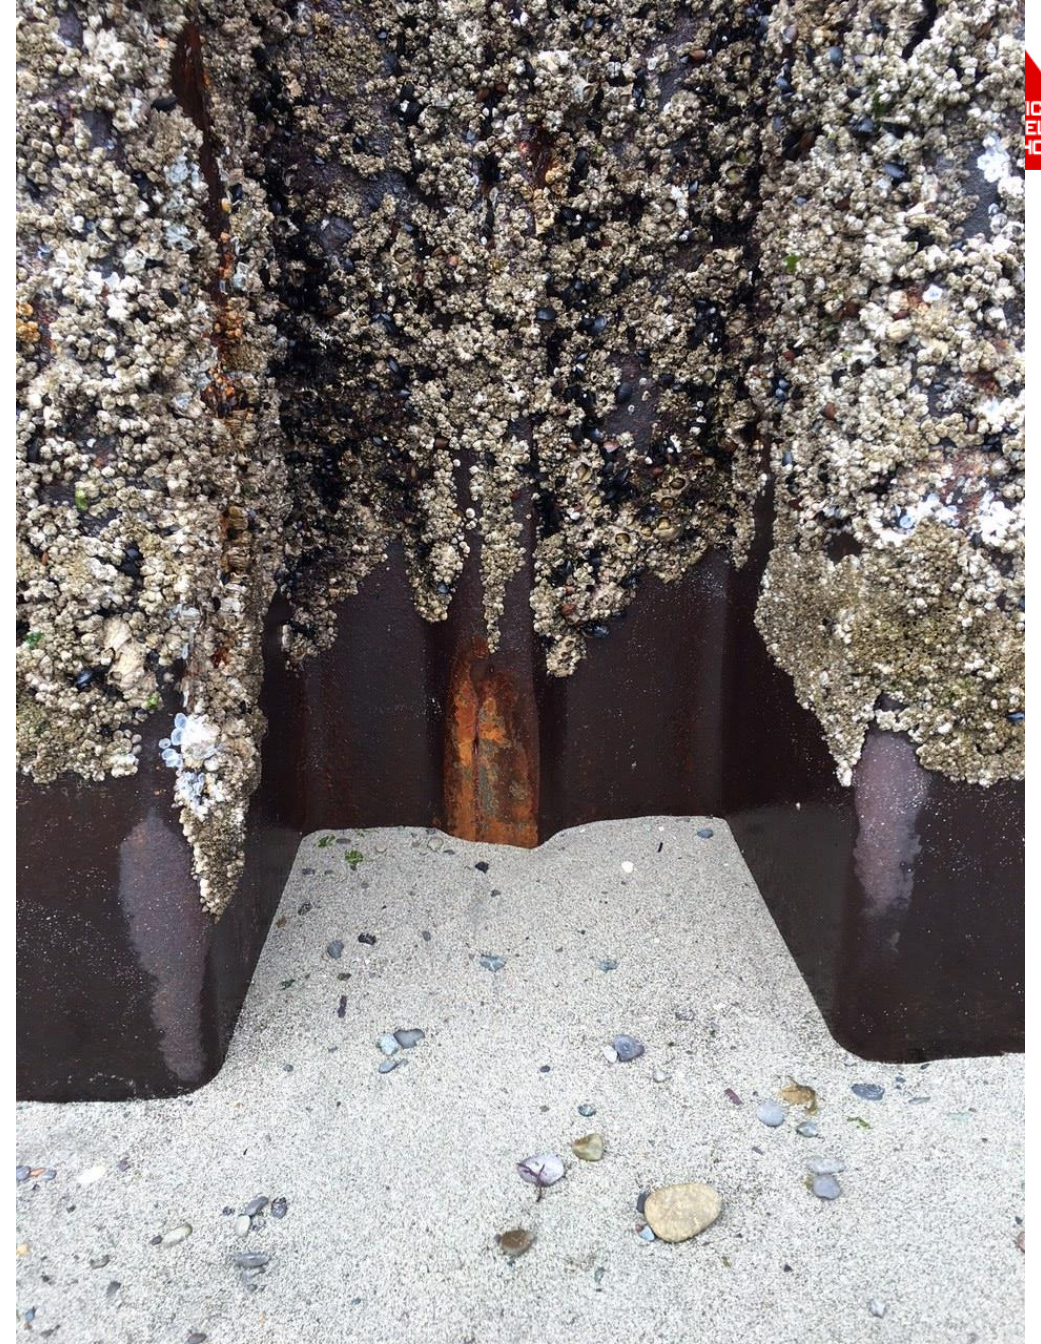
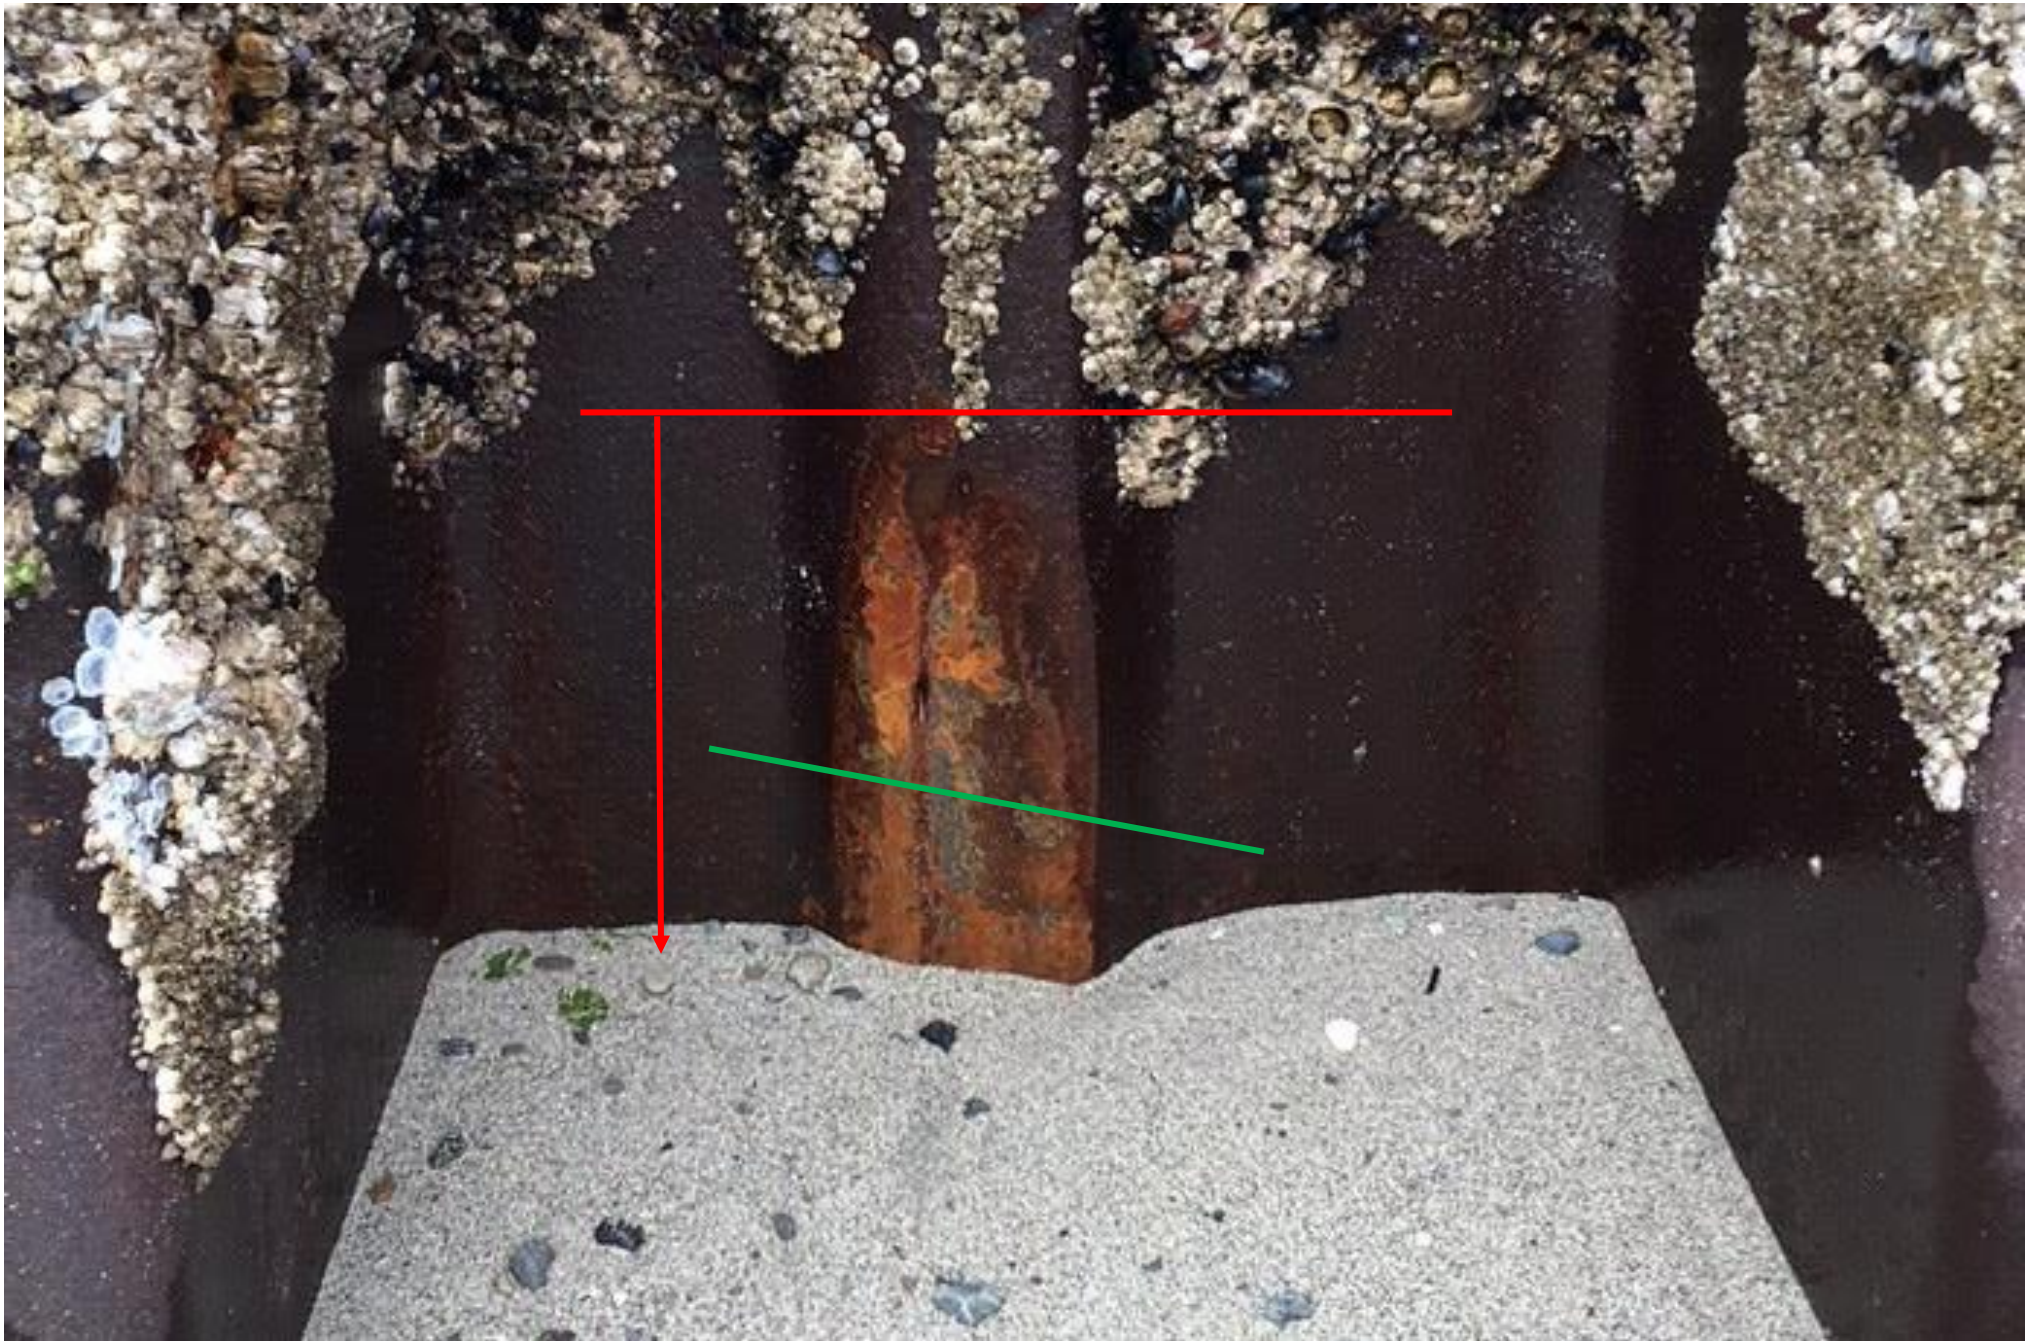
Complete erosion of frontal male lock finger at bed level
